Printronix Technical Bulletin	Number TB-0003	Revision A
Subject IBM/Infoprint™ 6500 Spool Printer End of Support	Product Type 6500 Spool	Date 15/6/2016
	Originator Technical Support	Page 1 of 2

Subject: IBM/Infoprint™ 6500 Spool Printer End of Support

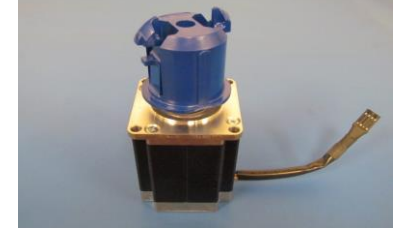
Ribbon Hub/Motor Assembly

- **Concern:** 6500 ribbon hubs will eventually crack, and the tabs that hold the ribbon in place are likely to break over time.
- **Encountered Problem:** Ribbon fails to reverse, and/or ribbon does not move at all or folds resulting in damage to the ribbon and print quality degradation.
