Printronix/TallyGenicom Technical Bulletin		Number TB-0007	Revision A
Subject TallyGenicom 62XX, 63XX, LG and LJ End of Support		Product Type TG 6200/6300	Date 15/06/2016
Note: Printronix, LLC Purchased TallyGenicom in 2009		Originator Technical Support	Page 1 of 2

Subject: TallyGenicom T6212, T6215, T6218, TG6306, TG6312, LG* and LJ* Series Printer End of Support

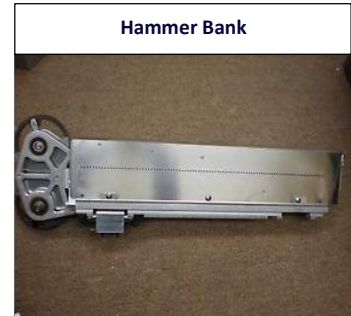
Hammer Bank/HammerSpring

- **Concern:** Hammer Bank Calibration/Hammer Spring (Frets) Tip wear over time.
- **Encountered Problem:** Poor print quality and unreadable barcodes due to improper dot formation. Light and dark areas of print, premature and reduced ribbon life.

Note: Calibrating the retract setting of each hammerspring is a highly precise process. Only the Printronix factory can warrant this process which requires special tools, jigs, training and calibration equipment. Relying on used, non-factory sources result in problems due to worn carbide tips, improper retract settings, resulting in needless expensive repairs and additional problems.
